This report presents the results of visual and photographic underwater surveys from the shoreline to a depth of 600 feet along selected routes off the eastern coast of Andros Island, Bahamas. Additional oceanographic and meteorological data are included which were obtained during previous surveys. This is the U. S. Naval Oceanographic Office's first survey utilizing SCUBA equipped divers and submersibles and represents a further expansion of our data collection and survey capabilities to provide a more lucid presentation of ocean environmental characteristics.

The survey was performed to provide information applicable to the installation of submarine cables in support of the U. S. Navy's Atlantic Undersea Test and Evaluation Center.

Between 5 through 20 May 1964, the U. S. Naval Oceanographic Office in conjunction with the U. S. Naval Photographic Center performed an onshore and underwater cable route survey off the eastern coast of Andros Island, Bahamas. Surveys commenced ashore and proceeded underwater offshore along predesignated bearings to a depth of 130 feet. Survey sites were Salvador Point, Big Wood Cay, Golding Cay, and Deep Creek. Following this phase of the survey a s

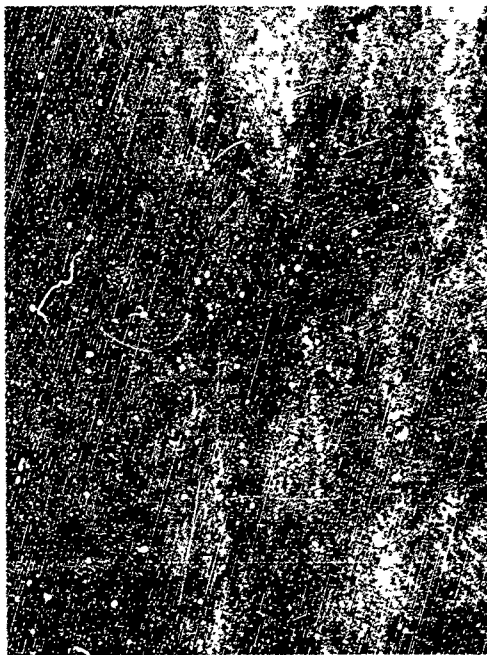
PLATE 9. BIG WOOD CAY (A) LAGOON BOTTOM BETWEEN BUOYS 1 TO 4, DEPTH 4 FEET (LOW TIDE), (C) & (D) LAGOON BOTTOM AT BUOY 5, DEPTH 5 FEET. ROUNDED CORAL (DIPLORIA CLIVOSA) IS 1 FOOT ACROSS.

The lagoon bottom between Big Wood Cay and the offlying reef varies substantially from the bottom off Salvador Point. Here the bottom consists of hard, eroded, and fractured rock which supports numerous and varied organisms. Sea fans and whips dominate the area and scattered coral heads provide relief of from 1 to 2 feet. Plates 8 and 9 are typical of the bottom throughout the lagoon. Lack of a thick sand covering and marine grasses indicates strong water circulation. Circulation is periodic and controlled by the ebb and flood of the tide in the channel between Gibson and Big Wood Cays where a current speed of 1 knot can be observed.

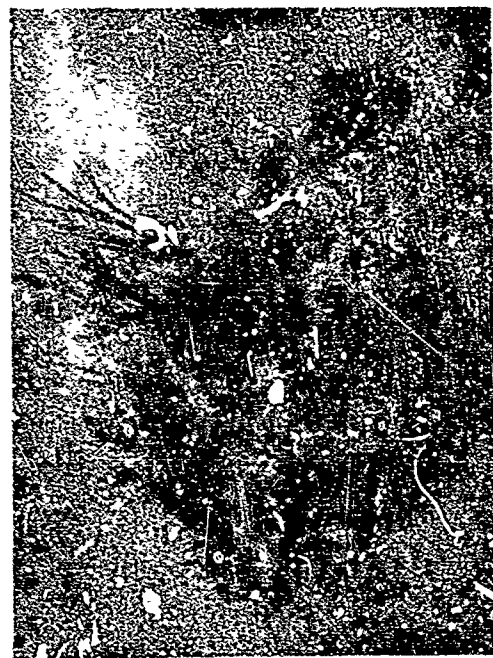
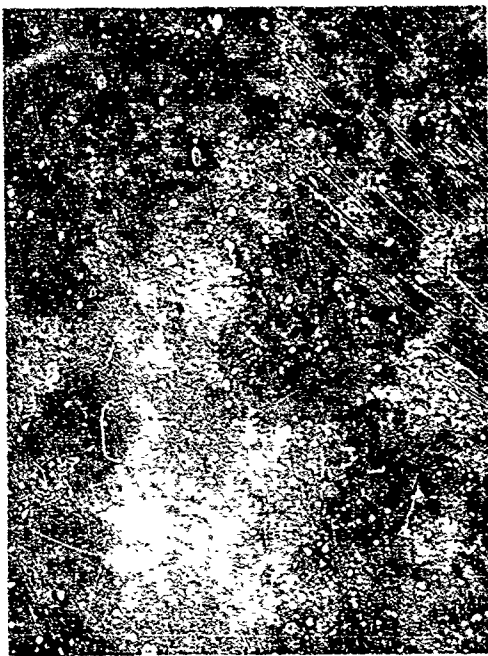
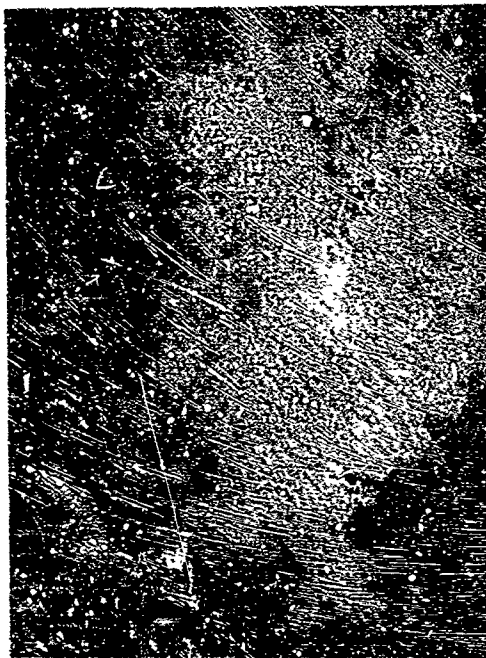
PLATE 10. BIG WOOD CAY (A) & (B) OUTER PLATFORM, DEPTH 18 FEET. HEAD IN (A) IS 8 FEET LONG AND 4 TO 5 FEET HIGH. DOMINANT CORAL IN (B) IS *MONTASTREA ANNULARIS*. (C) & (D) DEPTH 24 FEET SHOWING HEADS AND RIPPLE MARKED SAND ASSOCIATION.

The barrier reef is less distinct along the survey track off Big Wood Cay than at Salvador Point, and is delineated by an increase in coral abundance and species. A few hundred yards north and south of the survey track, the reef is well-developed and stands a few inches above the water surface at low tide. Seaward of the reef the outer platform is similar to that described at Salvador Point. The bottom changes from a forest of coral heads off-reef to a spur and groove configuration in intermediate areas, and finally to a texturally rough and abrupt break-in-slope (Plates 10 and 11).

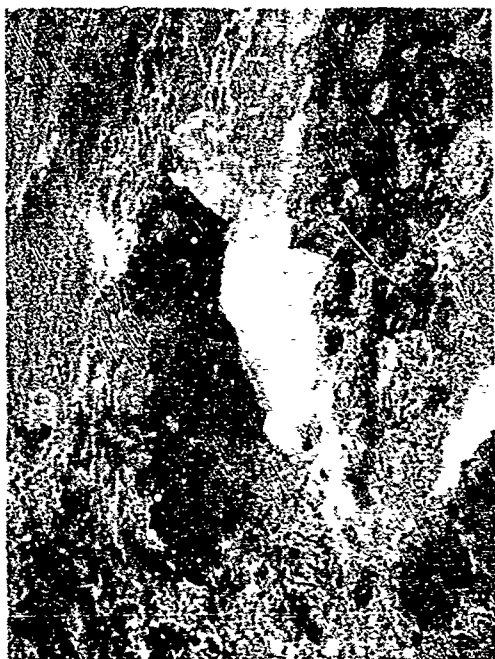
PLATE 12. GOLDING CAY (A) & (B) EASTERN SHORELINE, (C) & (D) DETAILED VIEW OF CAY ROCK. KNIFE IS 8 IN. LONG.

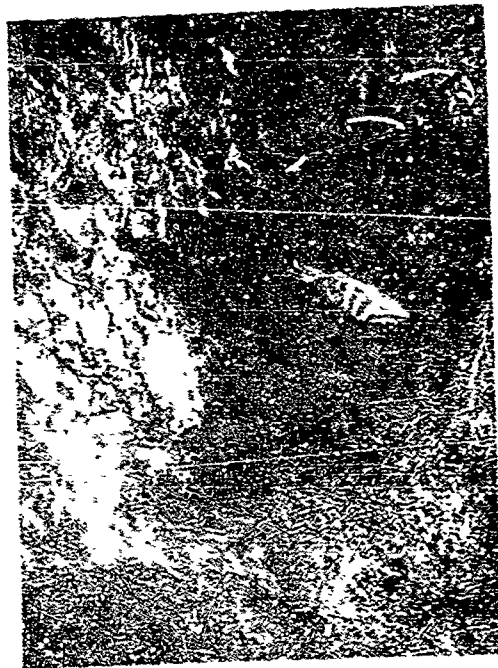
PLATE 23. HIGH POINT CAY, SERIES OF PHOTOGRAPHS SHOWING EDGE OF OUTER PLATFORM AT 130 FEET DEPTH.  
NOTE UNDERCUT WALL AT PLATFORM'S EDGE IN (A).

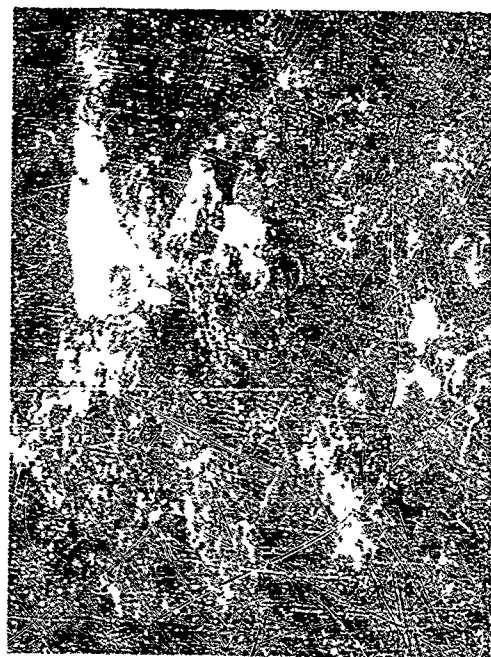
PLATE 26. REPRESENTATIVE PHOTOGRAPHS OF MARGINAL ESCARPMENT OFF GOLDING CAY. (A) 210 FEET. (B) 242 FEET. (C) 270 FEET. (D) 312 FEET.
